WELDING INSPECTION REPORT

Resident Engineer: Casey, William **Report No:** WIR-028461 Address: 333 Burma Road **Date Inspected:** 21-Sep-2012

Project Name: SAS Superstructure **OSM Arrival Time:** 700 **OSM Departure Time:** 1730 **Prime Contractor:** American Bridge/Fluor Enterprises, a JV Contractor: American Bridge/Fluor Enterprises, a JV **Location:** Job site

Bridge No: 34-0006 **Component:** OBG

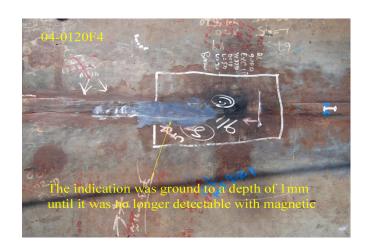
Lift 13E Deck drop-in longitudinal splice (Weld No. 13E-PP122-E2.5-BW1)

The QAI performed 50% verification of this weld from face A/B. A total of one rejectable indication was observed at the time of inspection from face A. The linear indication was located at the weld toe measuring a total of 110mm from Y3880~3990. The indication was ground to a depth of 1mm until it was no longer detectable with magnetic particle inspection. A White contrast background of the indication was used for photographic purposes only.
